Re: MS4 Inspection - Village of Patchogue  
NPDES Permit No. NYR20A268

**MS4 Inspection Report/Village of Patchogue, NY (NYR20A268)**  
**August 19-20, 2013**

Village of Patchogue, NY (Unedited photos taken by Jerry Ciotola, Environmental Engineer, USEPA Region 2, Water Compliance Branch, August 19-20, 2013)

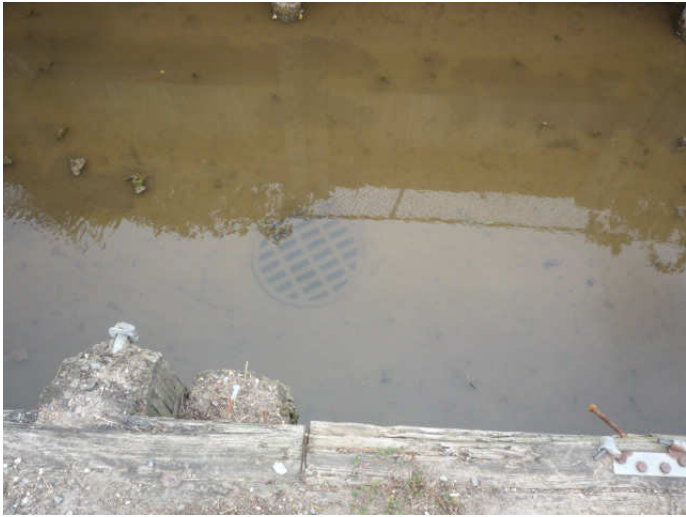
**Truck loading pit drain was clogged/submersed**

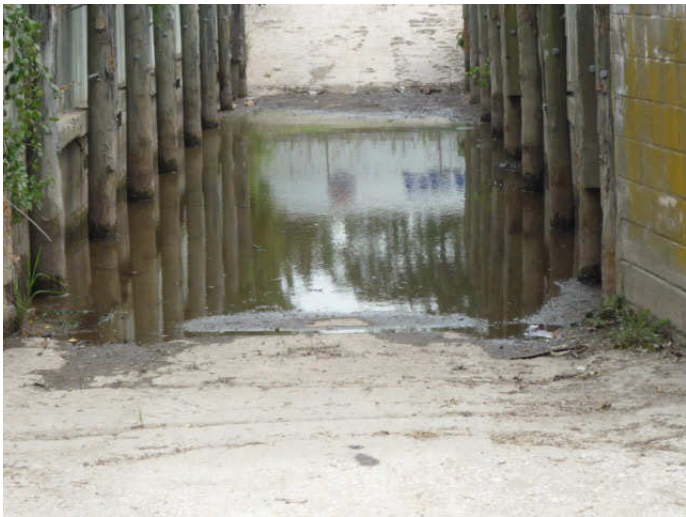
**Truck loading pit drain was clogged/submersed**

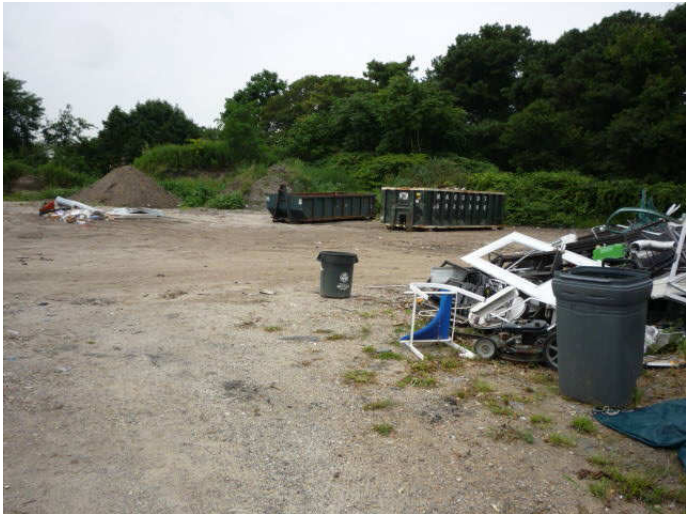
3. The garage does not have a designated truck wash area, and silt/sediment should be captured prior to reaching the infiltrating well.
4. At the recycling area, some trash haulers were not covered.

**Transfer materials and dumpsters should be covered**

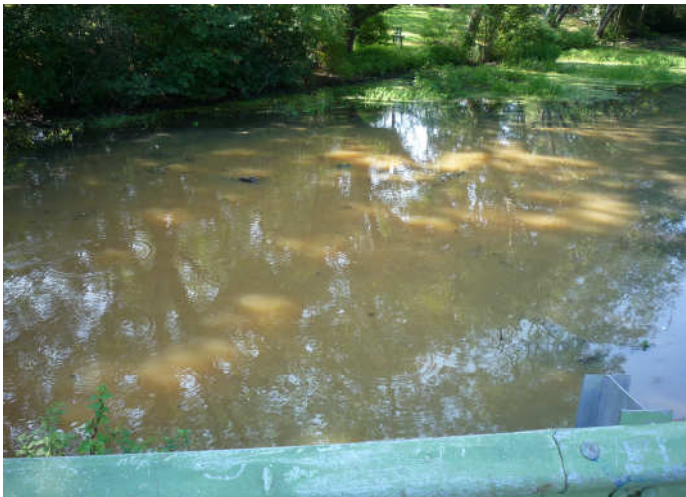
**At Gillette Ave and W Lakewood St appeared to be a broken pipe discharging into creek**

9. The potential ruptured main identified at Gillette Ave. and West Lakewood Street resulted in a sediment plume to the tributary, and should be repaired.
